Investigation into the Ashland Oil Storage Tank Collapse on January 2, 1988

NBSIR 88-3792

**John L. Gross
Felix Y. Yokel
Richard N. Wright
A. Hunter Fanney**

Issued June 1988

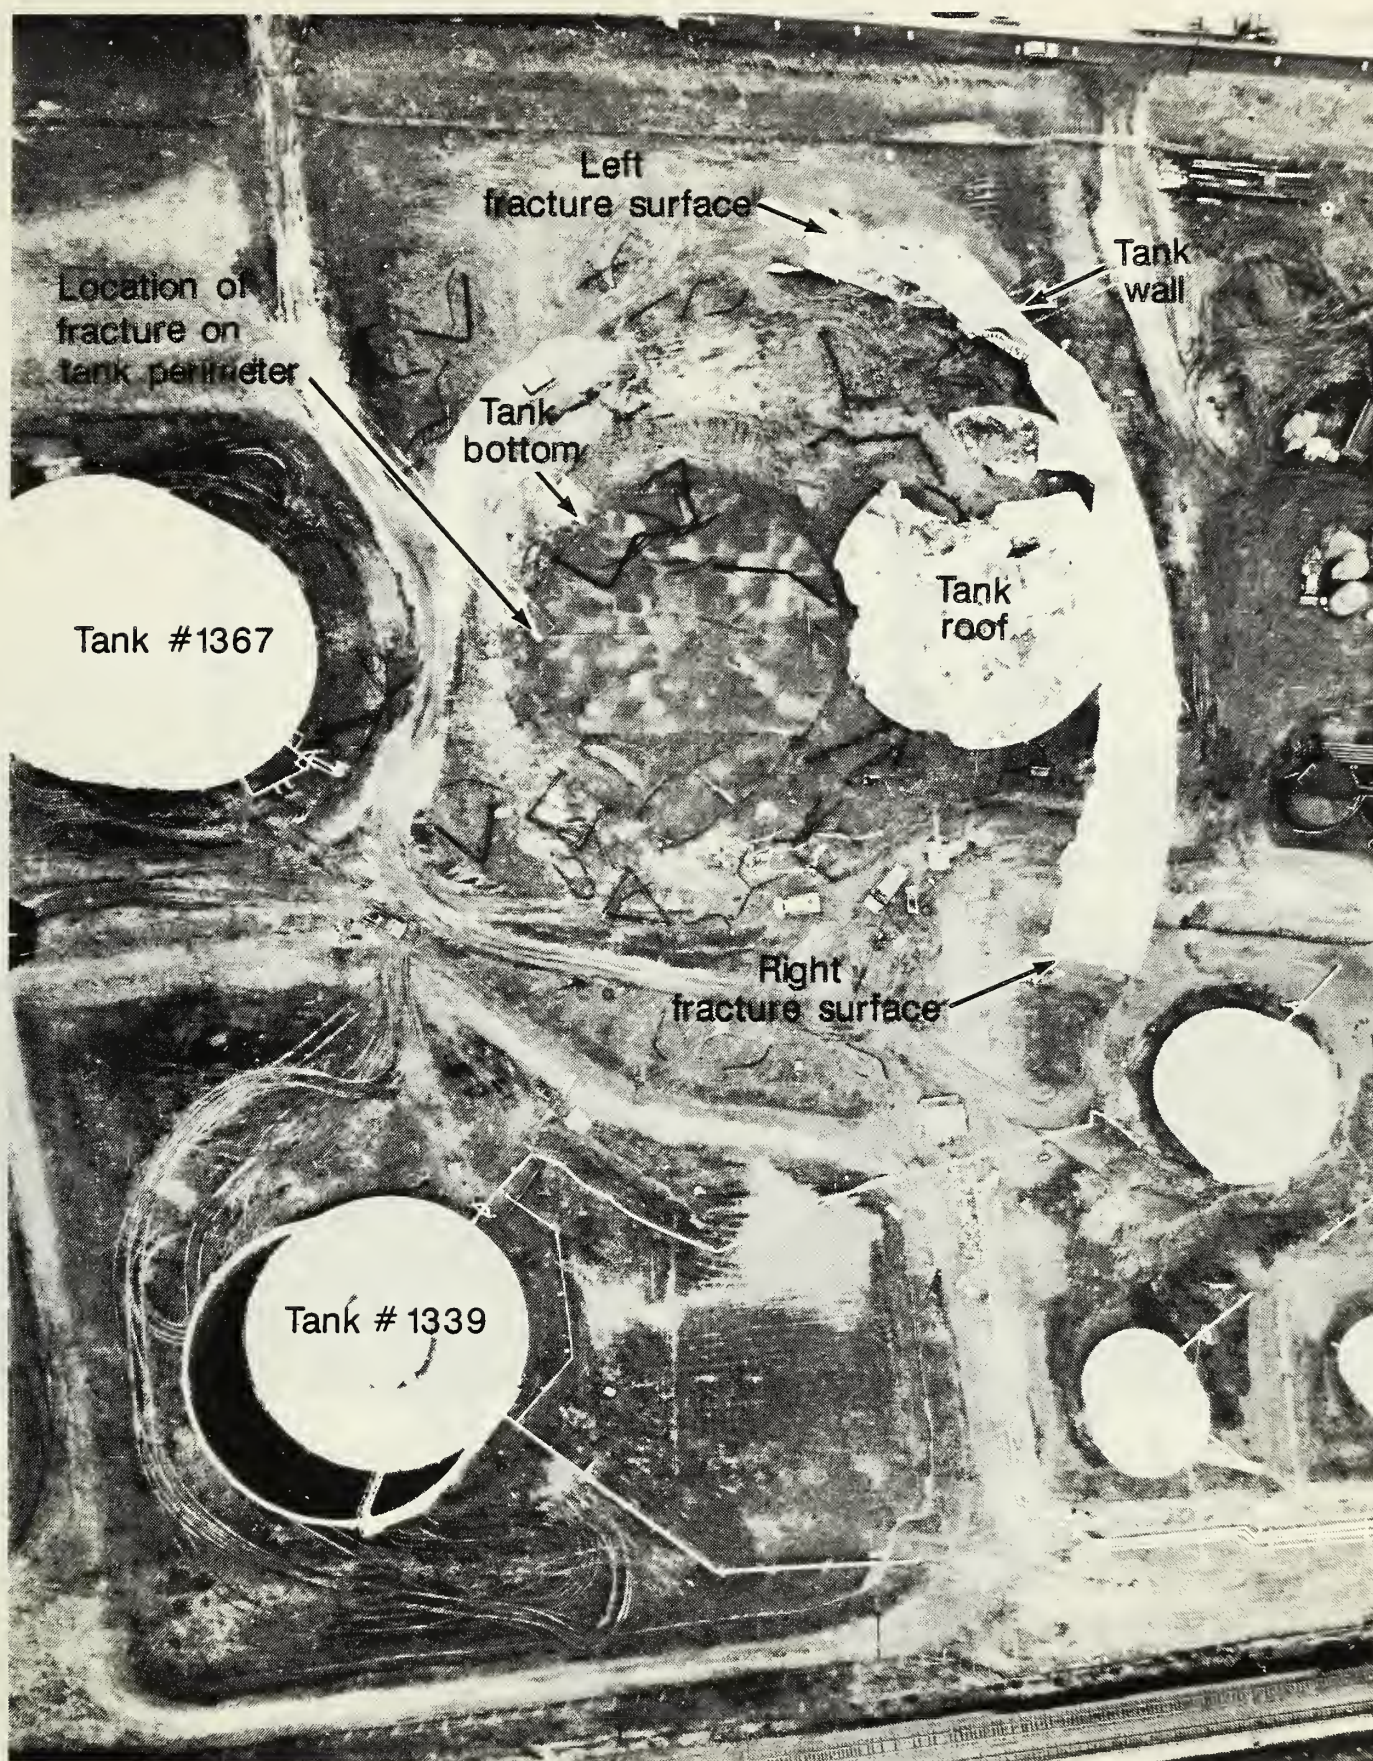
As can be seen from the aerial view of the collapse site shown in Figure 3.3 (3.3), the tank wall had split completely open and the once-cylindrical shell had unwrapped until it was nearly straight. The tank shell came to rest on top of a dike approximately 120 ft and generally north of its original location. A description of the fractured tank wall is given in the next section. A composite photograph of the collapsed tank from within the dike area is shown in Figure 3.4.

Debris from the roof support system lay scattered mostly within the dike area as can be seen in Figure 3.3. A closer view of some of the debris on the tank bottom is shown in Figure 3.7. The roof framing members were severely twisted

Figure 3.3 - Aerial View of the Collapse Site
(Photo by Pennsylvania Task Force)

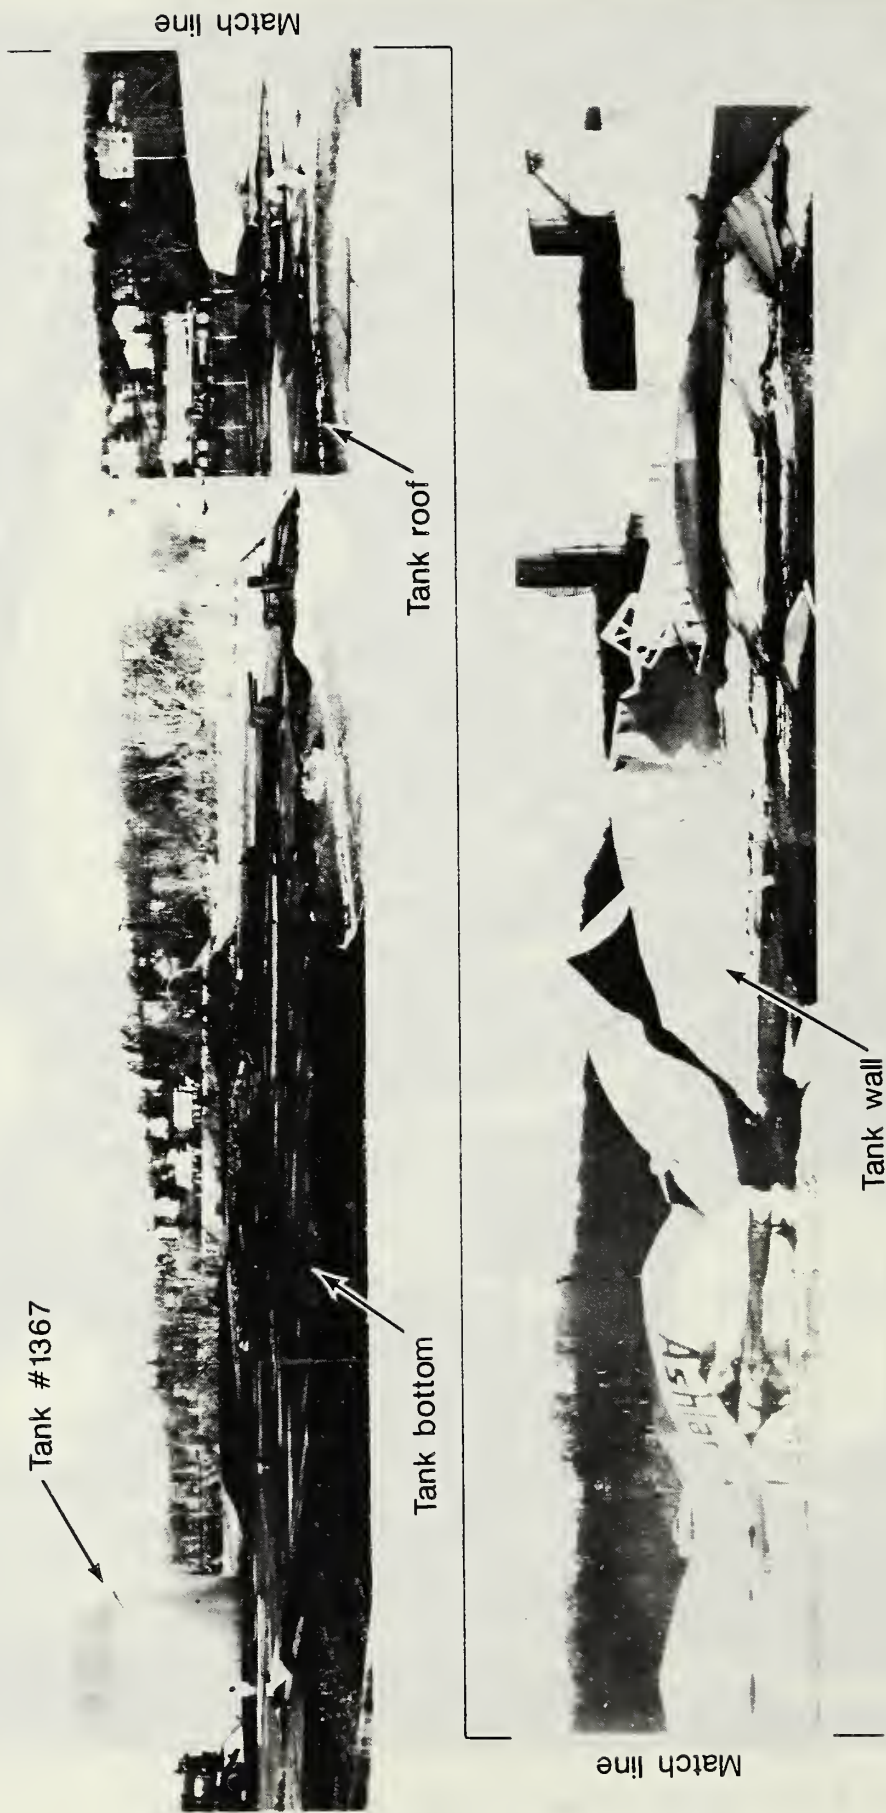
Tank No. 1367, which was empty at the time of the collapse, was severely dented on the side facing Tank No. 1338. Tank No. 1367 is partially in view at the left in Figure 3.4 and is shown in Figure 3.8. An oil stain was evident on this tank and on Tank No. 1339 extending as high as the roof line which was approximately 48 ft for both tanks.

Figure 3.4 - View of Collapsed Tank No. 1338 from Ground Level

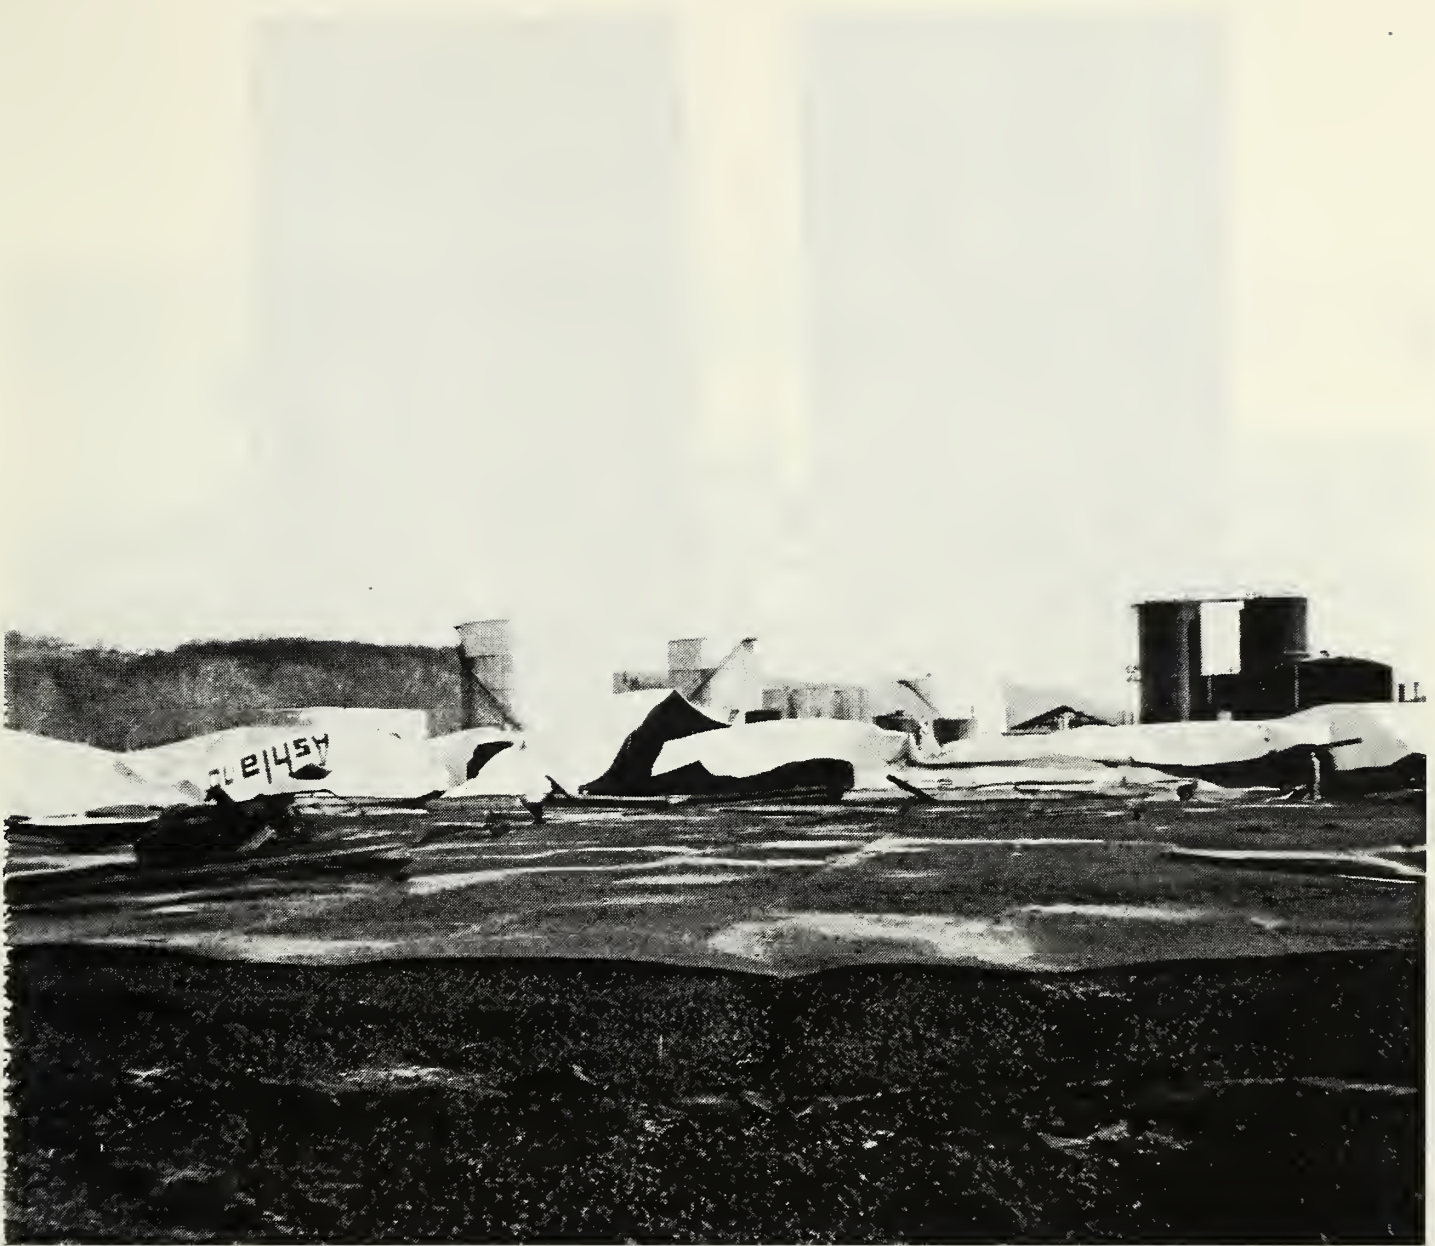
The wall was completely separated from the tank bottom. Figure 3.5 shows the tank bottom in the foreground and the tank wall and portions of the roof in the background. The bottom tore at the toe of the inside fillet weld attaching the first shell course to the bottom plate leaving a 3-inch "lip" attached to the tank wall (see Figure 3.6). This tear was ductile as evidenced by the approximately 45° failure plane. The tank bottom remained relatively intact except for two large tears in the lap welded seams. The edge of the bottom plate where the tank wall tore away had a "scalloped" appearance as shown in Figure 3.5.

Figure 3.5 - View of Tank Bottom with Tank Wall and Roof in Background

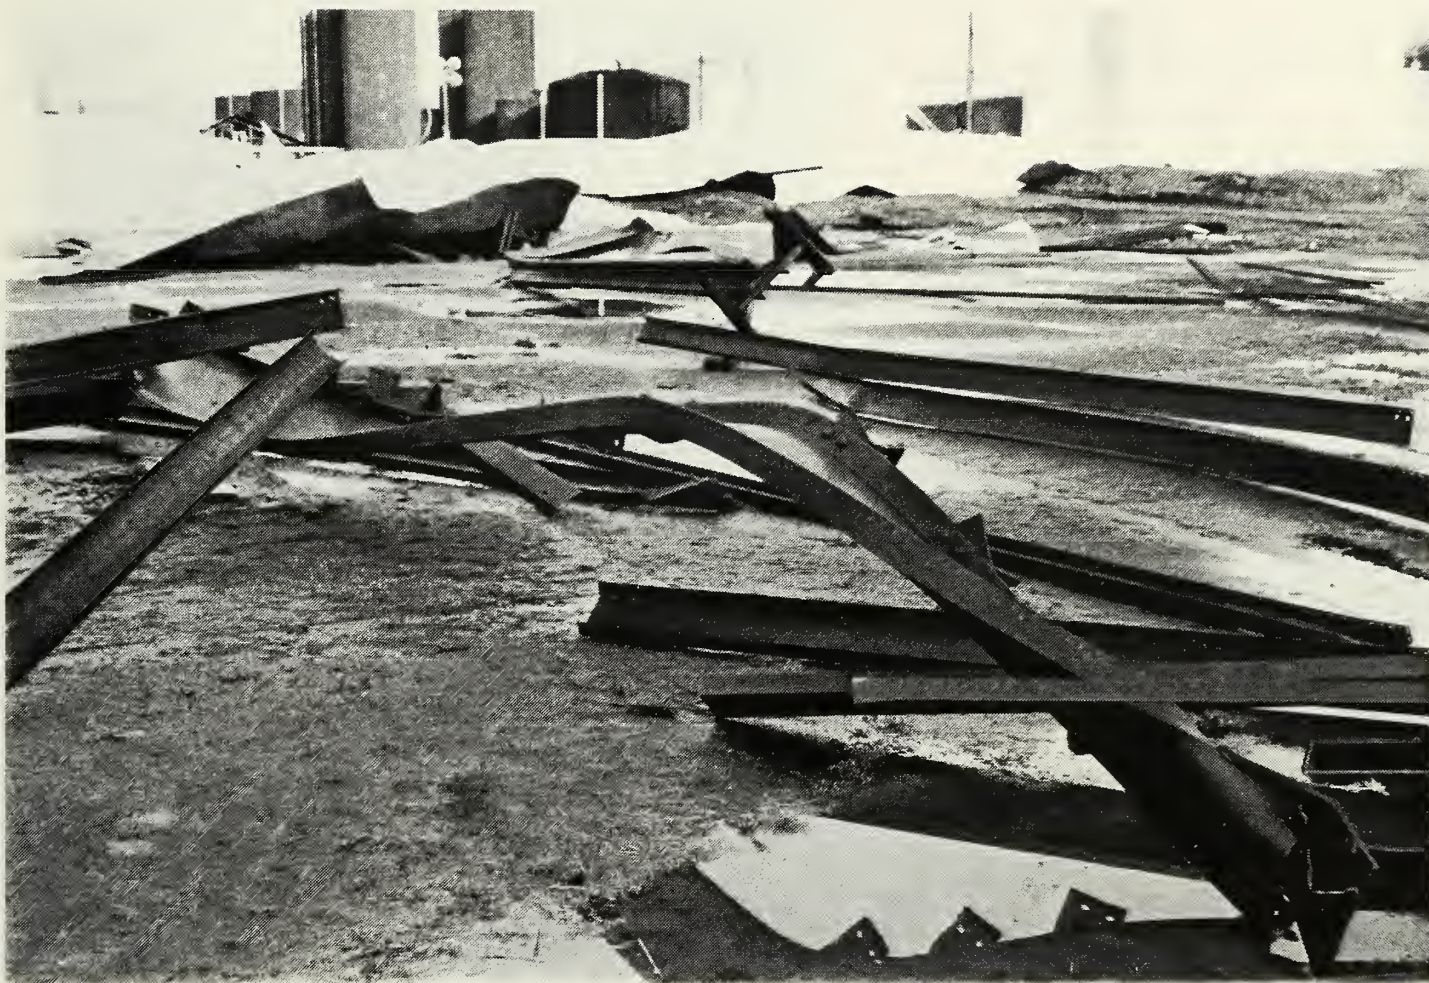
Figure 3.7 - Roof Framing Debris Scattered on Tank Bottom

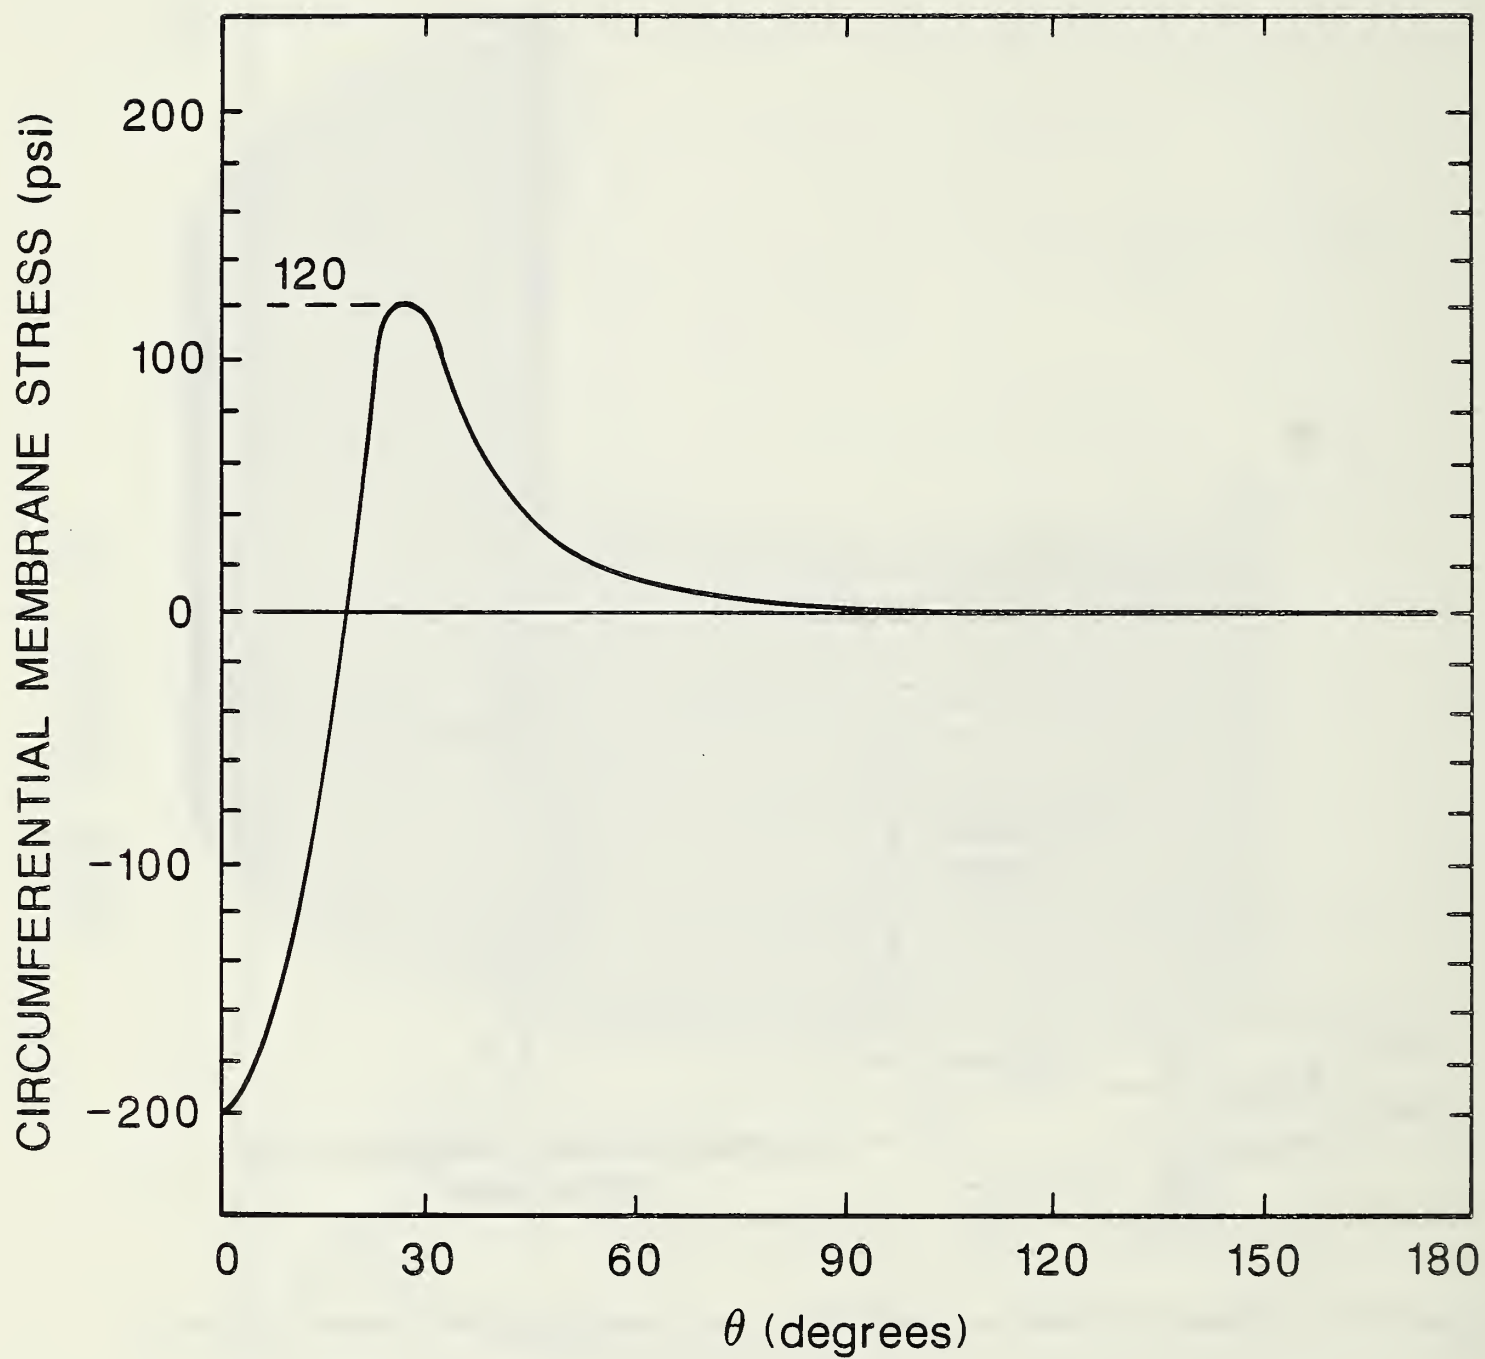
The maximum meridional membrane stress was approximately 3 ksi. Of more interest is the circumferential stress at the juncture of the first and second shell courses (height above tank bottom of the flaw). The membrane circumferential stress, plotted as a function of θ , is shown in Figure 5.5. As can be seen, the maximum tensile stress is approximately 120 psi and the maximum compressive stress is approximately 200 psi. The stresses are seen to decay to zero within 90° . From this analysis, it is seen that localized differential settlements on the order of 0.04 ft (approximately 0.5 in) would produce tensile membrane stresses in the vicinity of the flaw of only 500 psi. Thus, it is unlikely that any differential foundation settlements contributed significantly to the tensile stress normal to the flaw.

Figure 5.5 - Circumferential Stresses in the Tank Wall at a Height of 8 ft due to an Assumed Differential Settlement of 0.01 ft

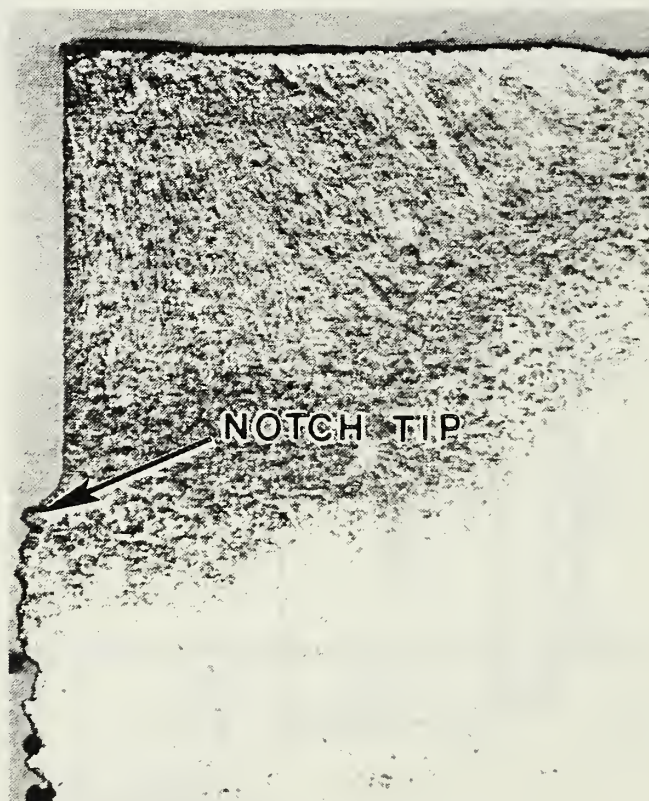
Figure 7.12b - Hardness of Embrittled Zone in Single-Edge Notched Bend Specimens

<u>Depth (in)</u>	<u>Hardness</u>
0.020	HRC 35
0.040	HRC 36
0.060	HRC 37
0.080	HRC 43
0.100	HRC 31
0.120	HRC 27
0.140	HRB 85
0.160	HRB 80

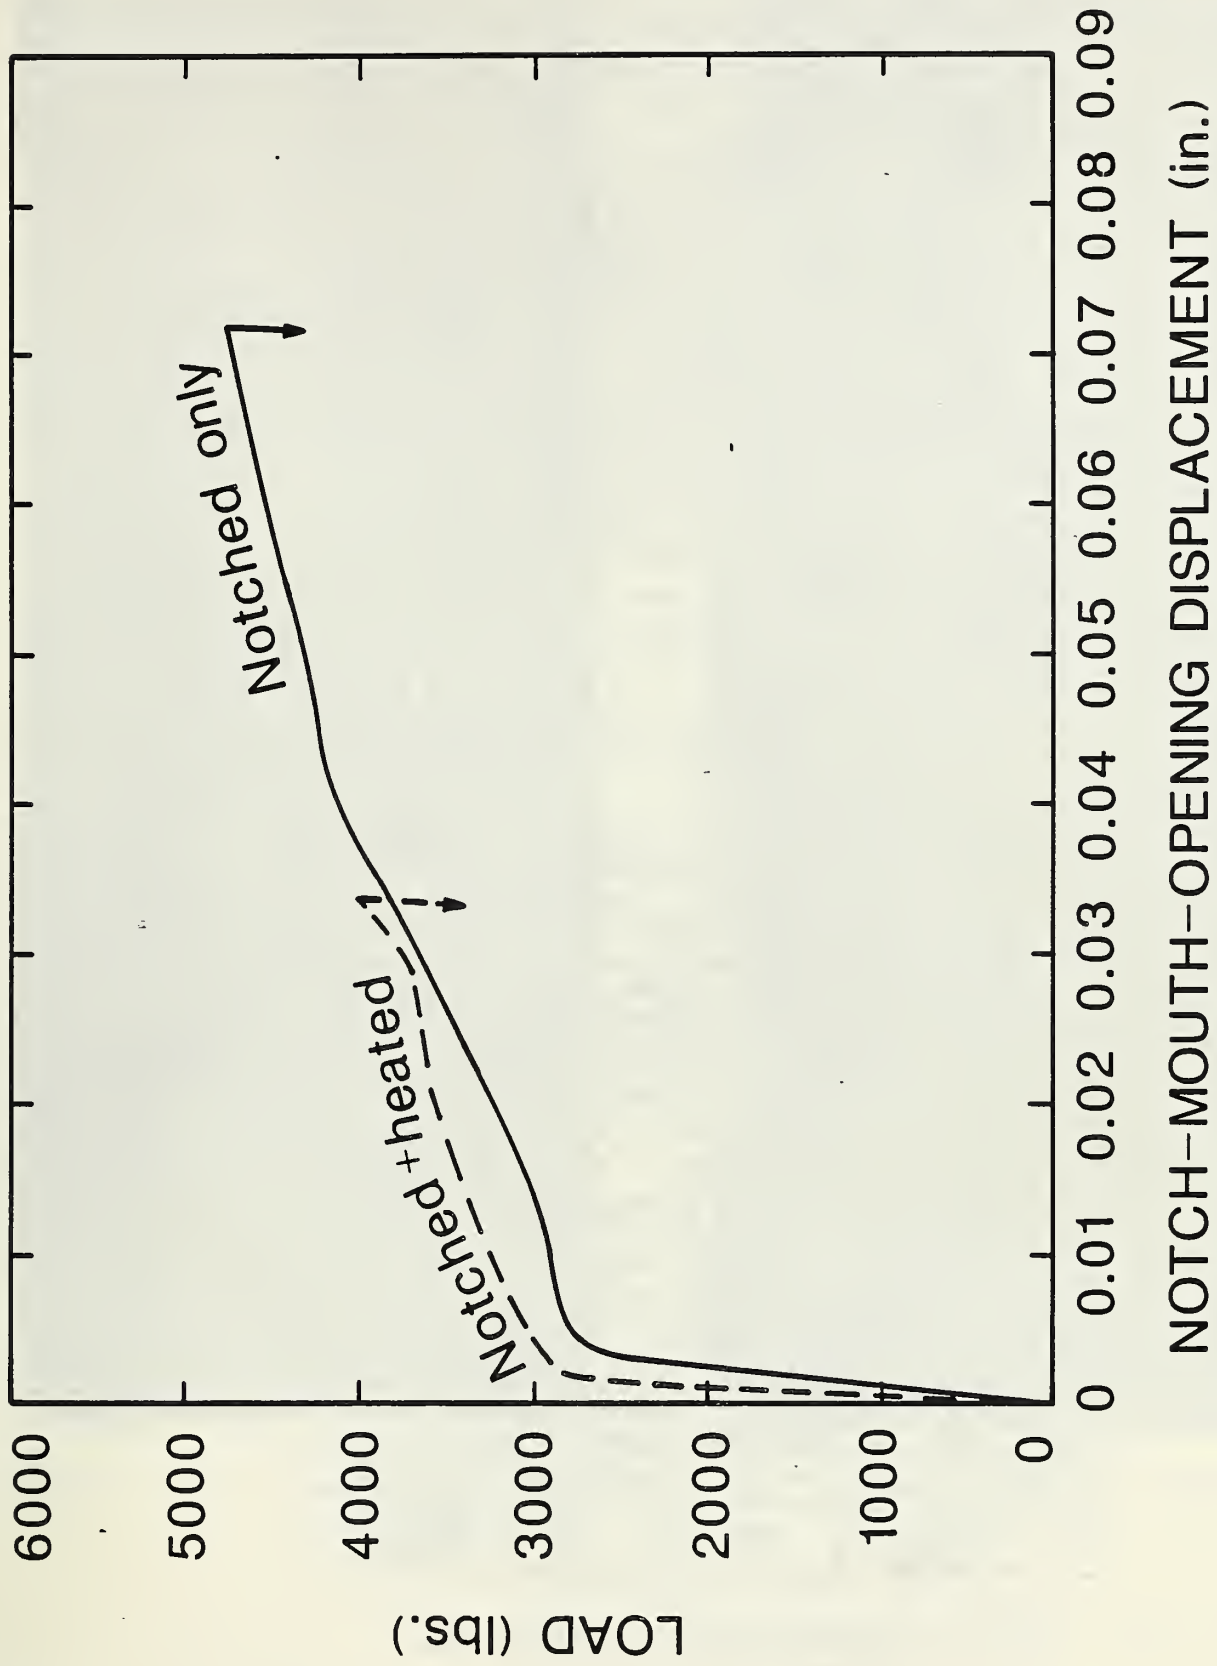
Figure 7.13 - Results of Notched-Bend Test

In this investigation, the effect of the heat-affected zone on the steel is determined from the load/displacement curve. It is seen in Figure 7.13 that the notch mouth-opening displacement at the maximum load (point of fracture initiation) for the heat affected (embrittled) specimen was 0.032-inch compared with a value of 0.072-inch for the notch mouth-opening displacement for the normal steel plate. The area under the load-displacement curve, (Figure 7.13) which can be expressed in terms of energy, can also be taken as a measure of the tendency to fracture. For example, two specimens that were tested at 40° F with just a notch in the base metal had energy values at maximum load equal to 21.4 and 21.7 foot-pounds. A similar specimen tested at 40° F, in which the metal had been embrittled by heating before cutting the notch had an energy at maximum load of 9.0 foot-pounds and a specimen that was heated after cutting the notch had an energy at maximum load of 9.7 foot-pounds. It was found that the energy to initiate fracture in the notched and heat embrittled specimens at 40° F was less than one half the energy to initiate fracture in the steel base metal that had not been embrittled by heating.

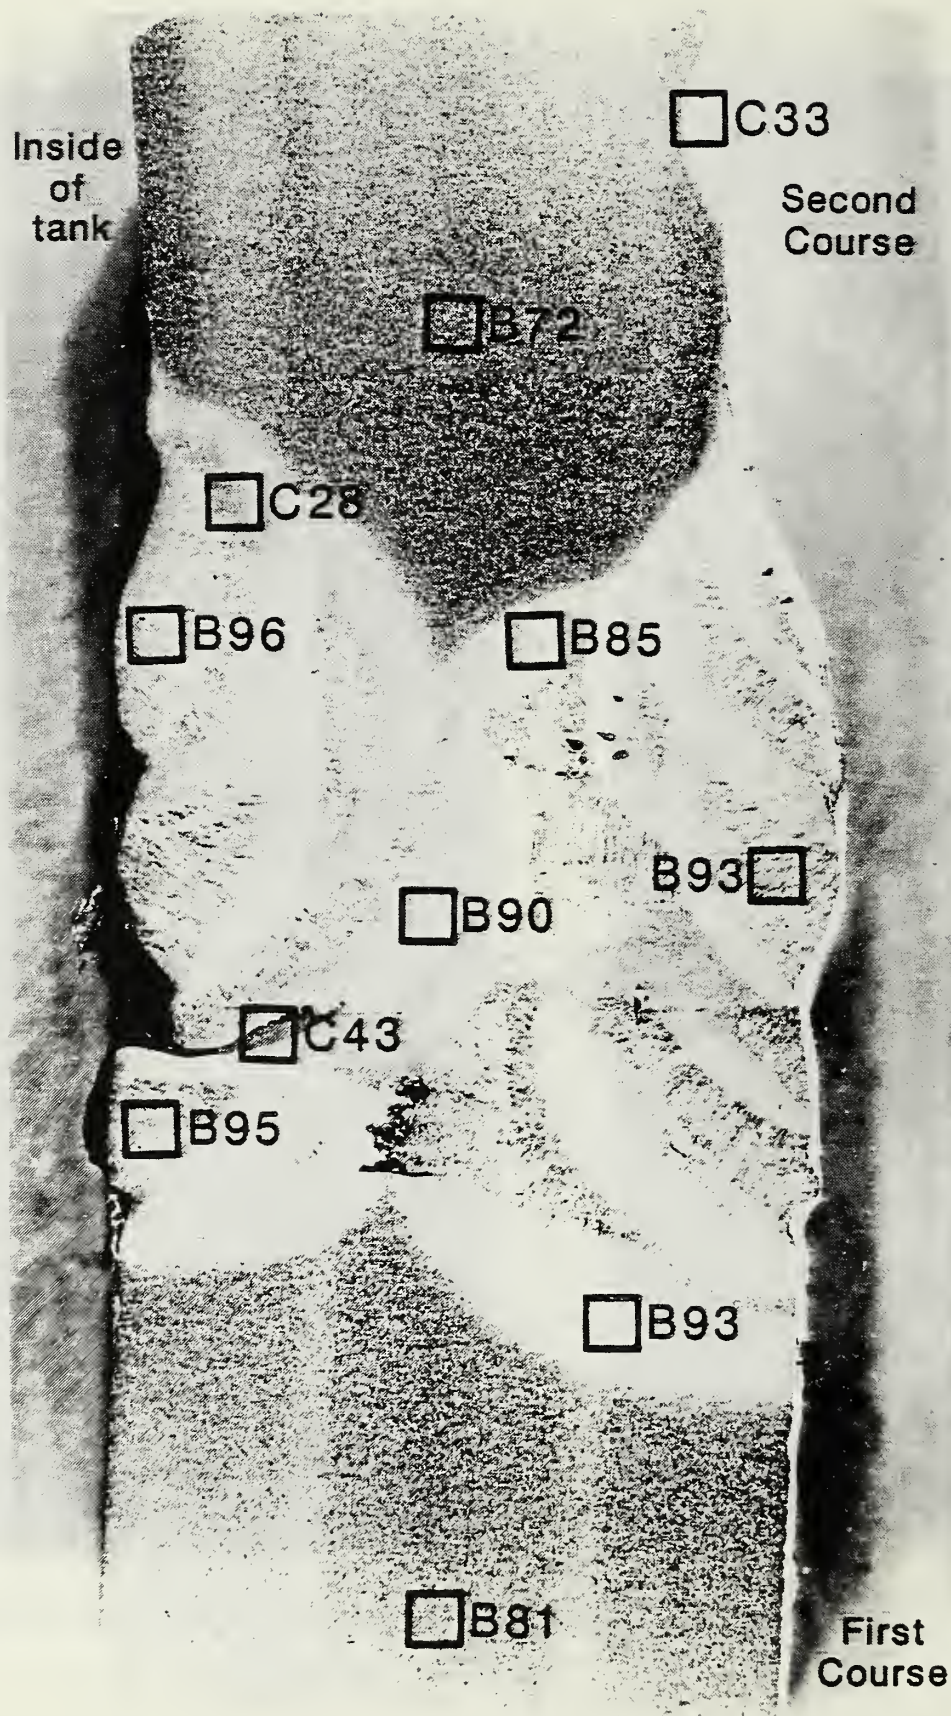
Figure 7.16 - Microstructure and Hardness of Horizontal Weld Metal

Rockwell B and C Scale Hardness Values are given for various Locations.

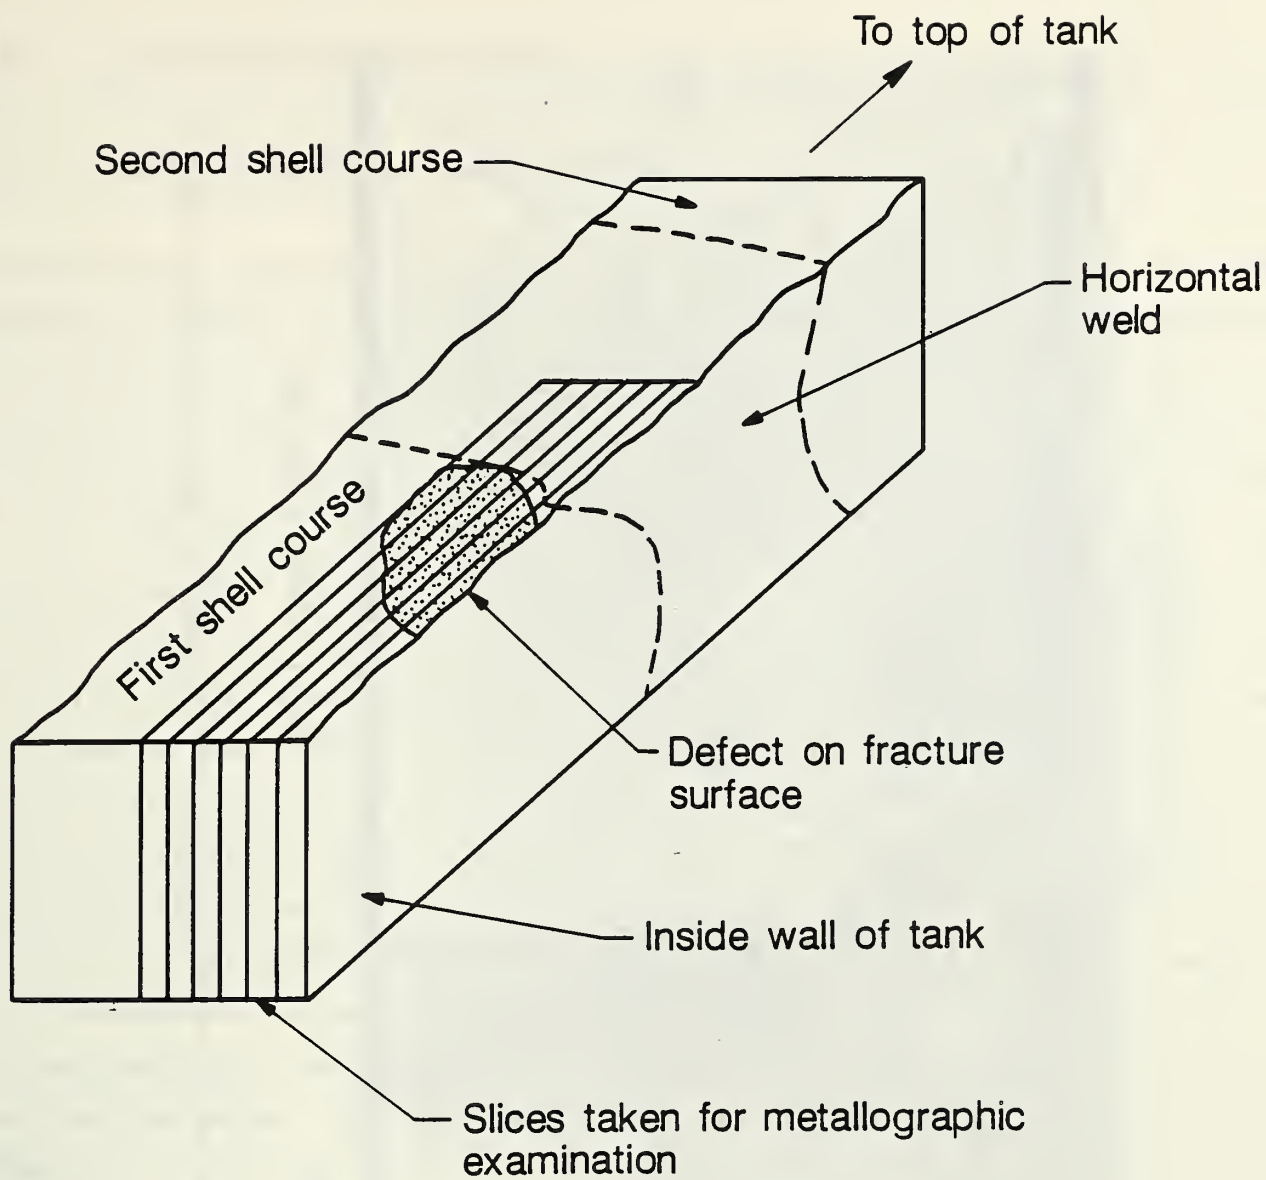
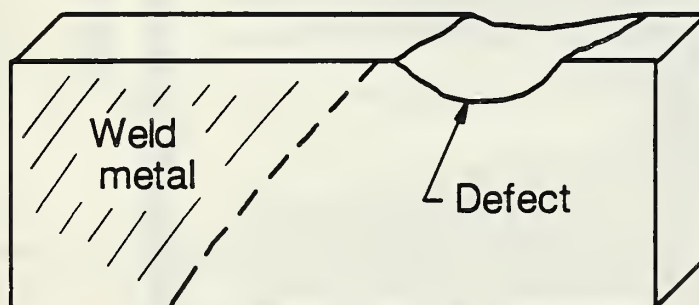
Figure 7.25 - Details of Sectioning to Determine Location of Defect

To determine the exact location of the defect with respect to the new weld metal, old weld metal, and first shell course plate, the sample shown in Figure 7.24 was sectioned as shown in Figure 7.25. The sections were cut using a fine wire electrodischarge machine. Eight specimens were cut at intervals of 0.080 in starting from the inner surface of the tank. These specimens were then examined metallographically to permit a 3-dimensional reconstruction of the defect to be made and to determine the exact location of the defect. An example of one of these sections is shown in Figure 7.26. This figure shows that the defect was located entirely in base metal from the first shell course. The edge of the defect extended just to the edge of the heat affected zone of the old weld metal.

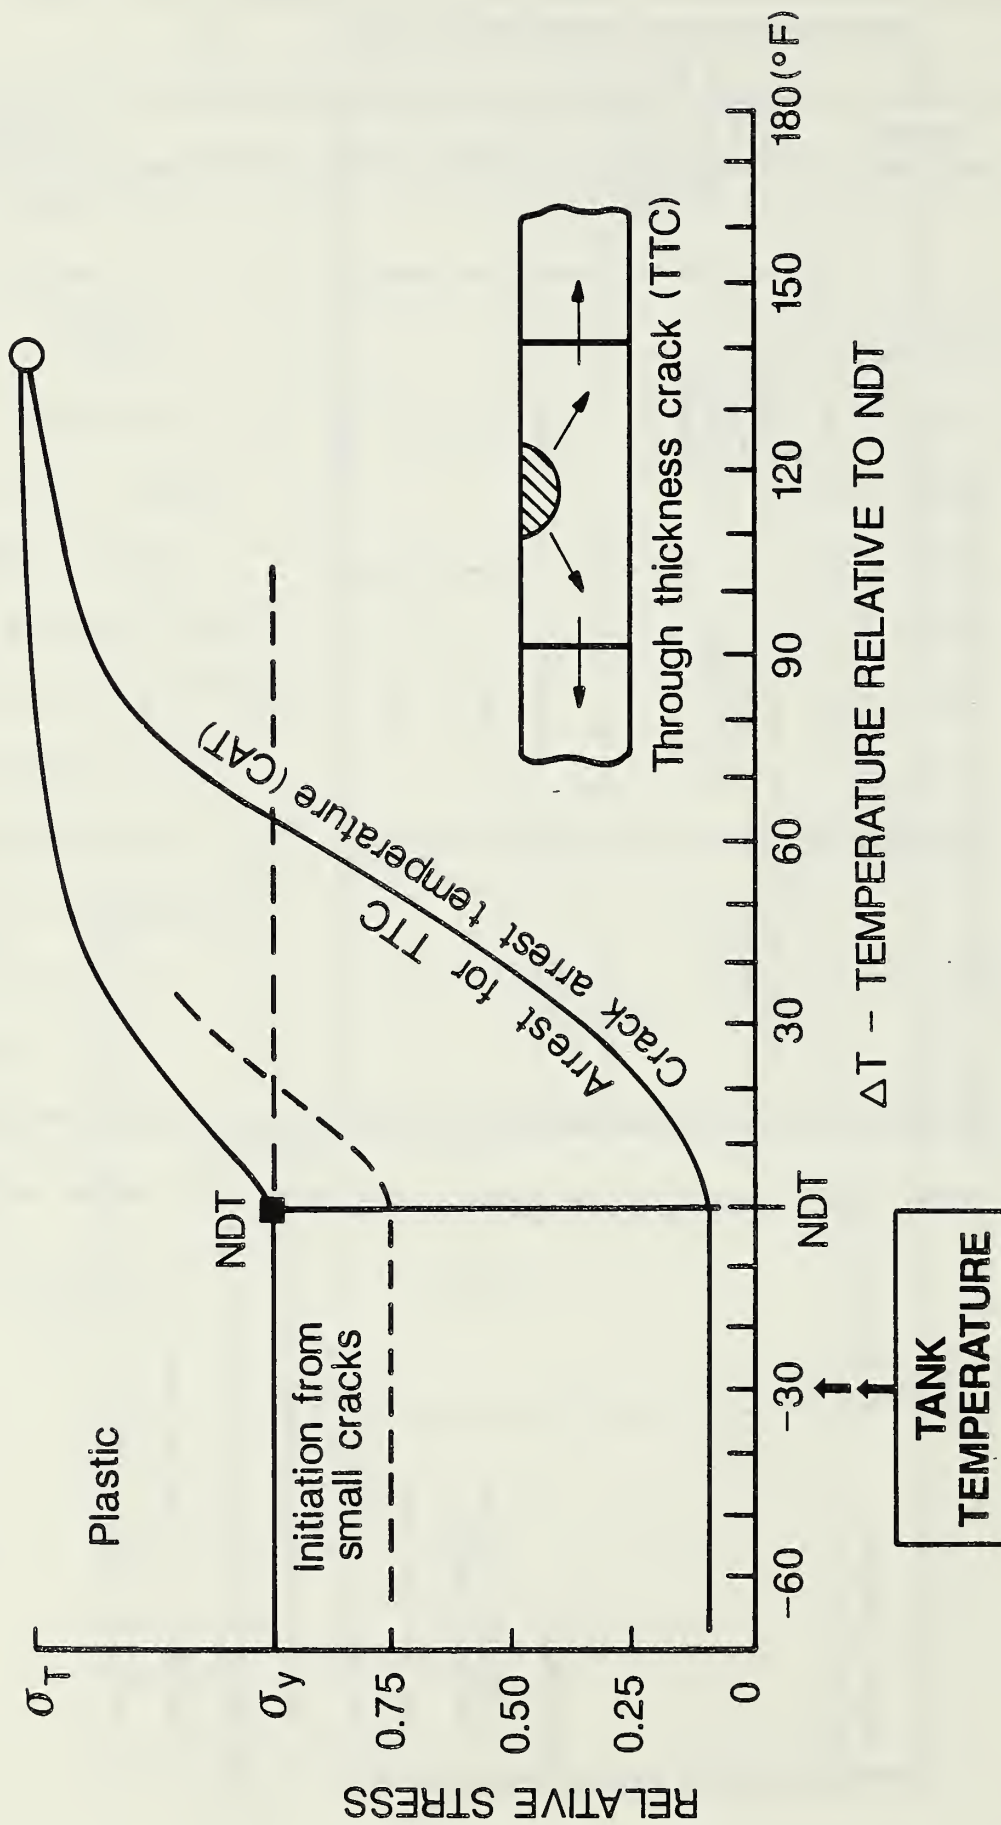
Figure 8.1 - Fracture Analysis Diagram (FAD)

A more exact, but still empirically based, procedure to assess the probability of fracture initiation and arrest is the determination of the drop-weight nil-ductility transition (NDT) temperature. This NDT temperature is used in conjunction with the generic Fracture Analysis Diagram (FAD), shown in Figure 8.1, to make an assessment of the probability of fracture initiation and arrest [8.4]. The Fracture Analysis Diagram provides a generalized description of the relationships between the crack size, relative stress, and operating temperature relative to the NDT. At temperatures below the NDT, the Fracture Analysis Diagram predicts that fracture will initiate from small defects (typically less than 1-inch in length) at stress levels below the yield strength of the steel and that the fracture will be brittle in nature. As seen in Table 7.8, the NDT for the first and second shell course steel plates was 20° F to 40° F above the operating temperature of the tank at the time of the failure. Based on the measured NDT and the Fracture Analysis Diagram, fracture initiation is predicted to be likely to occur in this tank at the operating temperature of 32° F.

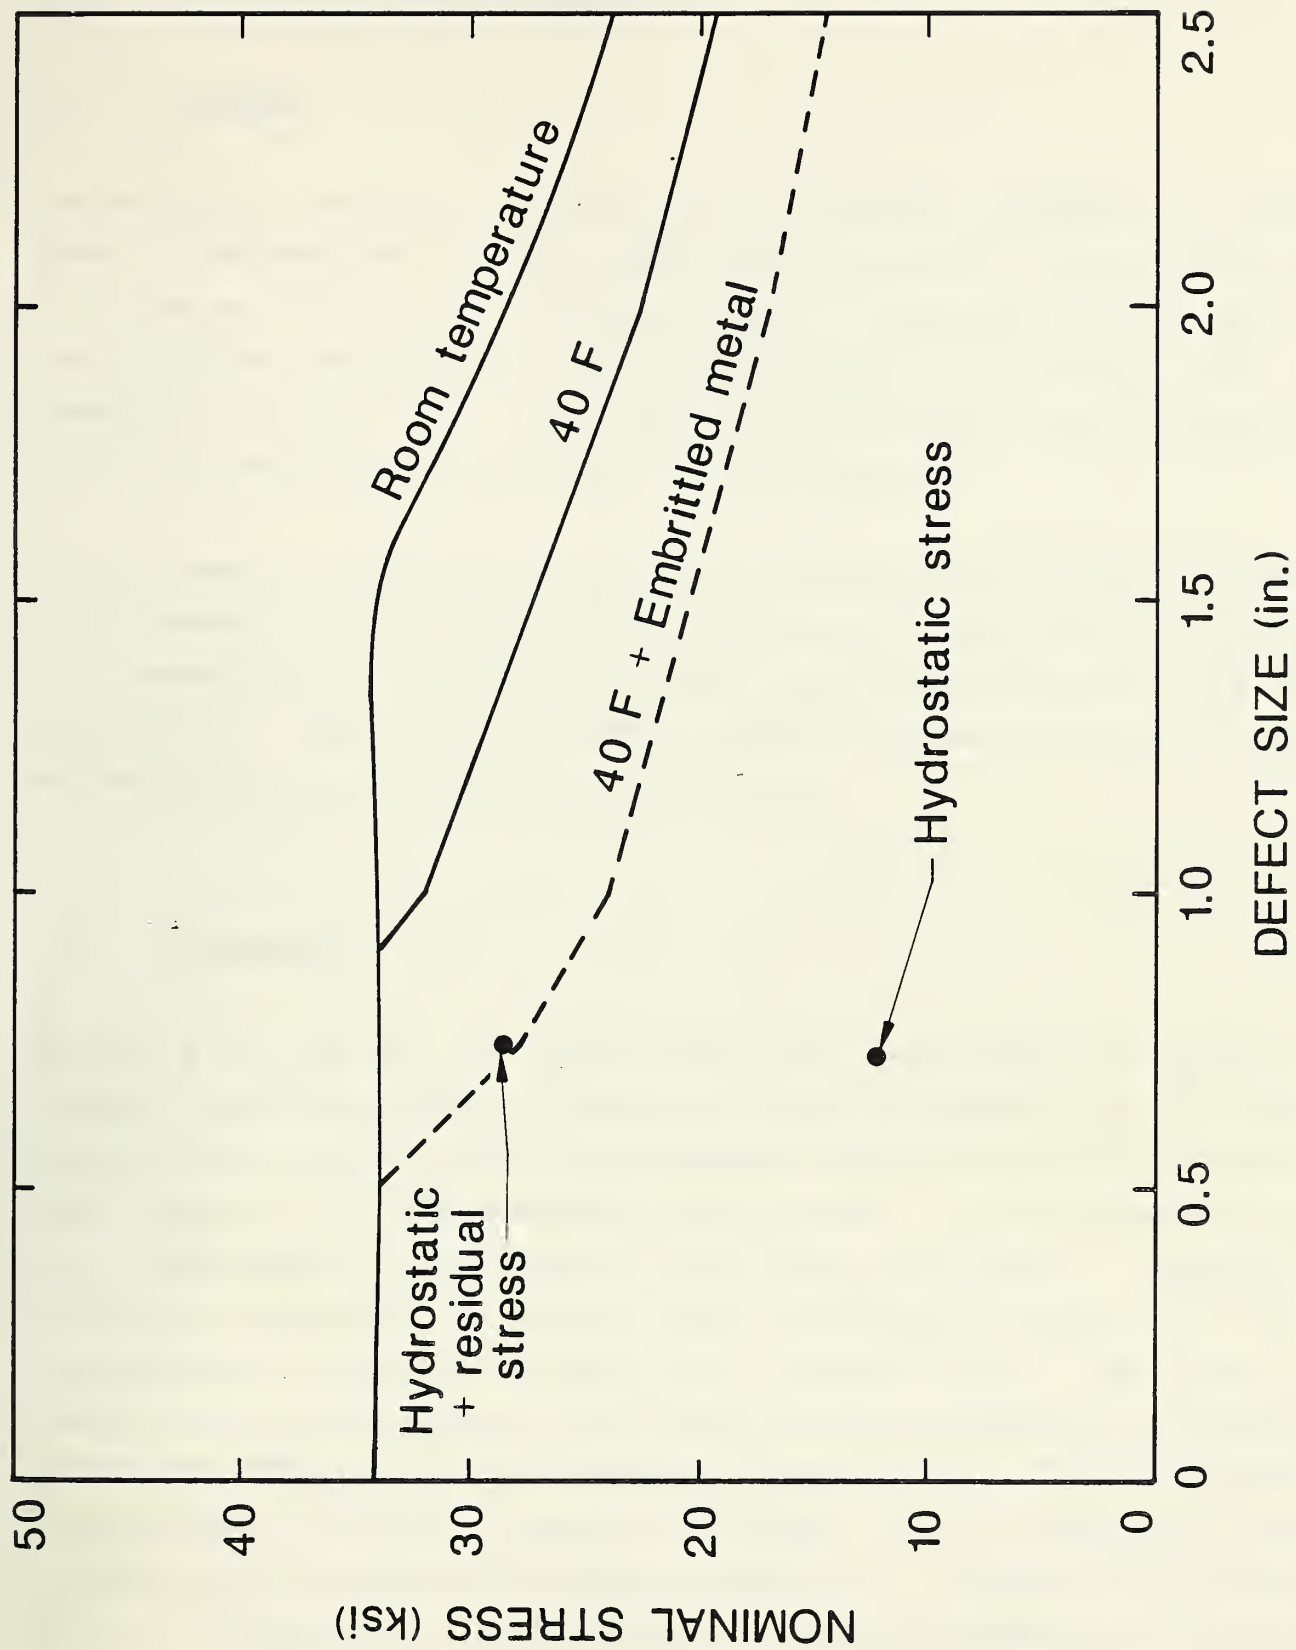
Figure 8.2 - Calculated Stress - Defect Size Relationship for Through-Wall Defect

For all cases considered in the fracture analysis, the calculated applied stress intensity for the defect identified as the fracture origin was substantially below the stress intensity required to initiate fracture and cause rupture of the tank. This can readily be shown by the stress-flaw size curve shown in Figure 8.2. For the measured toughness ($47.7 \text{ ksi}\sqrt{\text{in}}$) the

relationship between the nominal applied stress and the length of a through-thickness defect is calculated. Combinations of nominal stress and defect size that lie above the line shown in Figure 8.1 are predicted to cause fracture initiation and any combination of defect size and nominal stress that lies below the curve is not expected to result in fracture initiation. As can be seen from the points plotted in Figure 8.1, fracture is not expected to be initiated from a through-thickness defect of the length of the defect found on the fracture surface (0.742 inch.) even if the stresses in the vicinity of the defect are equal to the yield strength of the steel plates. Therefore, additional causes must be identified to determine why the tank ruptured. For the fracture analysis to predict rupture of the tank, either the defect must be significantly larger than the size identified on the fracture surface or the fracture toughness of the steel plate must be lower than that measured in this investigation.
